NewLife Intensity[®] 10

Troubleshooting Guide

Follow this guide for alarms, issue indicated, and actions to be taken.

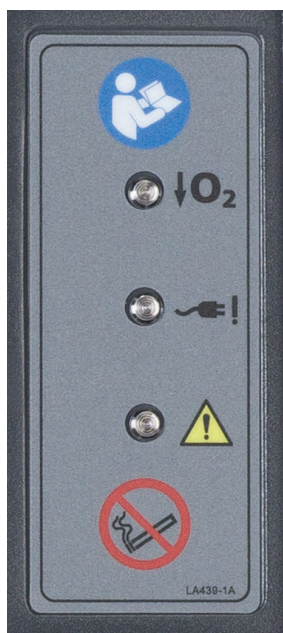
Indicator

Issue

Action

Oxygen output concentration has fallen below 90% (+5.5%/-3%)

Remove cannula and humidifier bottle (replace as needed), ensure 12 inches (30.48cm) clearance on all sides around unit, ensure flow ball is indicating flow of more than 2 LPM and equal to or less than 10 LPM, clean/replace Air Intake Filter, replace felt filter.

Loss of power while unit power switch was in the "ON" position

Ensure unit is plugged in to a functional power receptacle with proper outlet power, reset the Circuit Breaker on the front panel of the unit*, check power cord for damage (if damaged a biomed technician will need to replace).

If any of these conditions occur, this warning will illuminate:

- Obstruction of flow
- High or low device pressure
- High temperature

1. Remove any tubing or humidifier attached to the unit; replace as needed.
2. Ensure outlet flow is at or above the minimum flow of 2 LPM.
3. Ensure outlet flow is at or below the maximum flow of 10 LPM.
4. Maintain the required 12 inches (30.48 cm) of clearance around unit, ensure inlet filter is clean, ensure unit is not near a heat source, and ensure unit is within normal operating temperature range 41°F to 104°F (5°C to 40°C).

*If the circuit breaker on the front of the unit is tripped (popped out), set the switch to the 0 (off) position, disconnect power, and press the circuit breaker button in to reset. Then plug the unit in and set the switch to the I (on) position.
